ERP ALERT #12

WORK IN PROGRESS

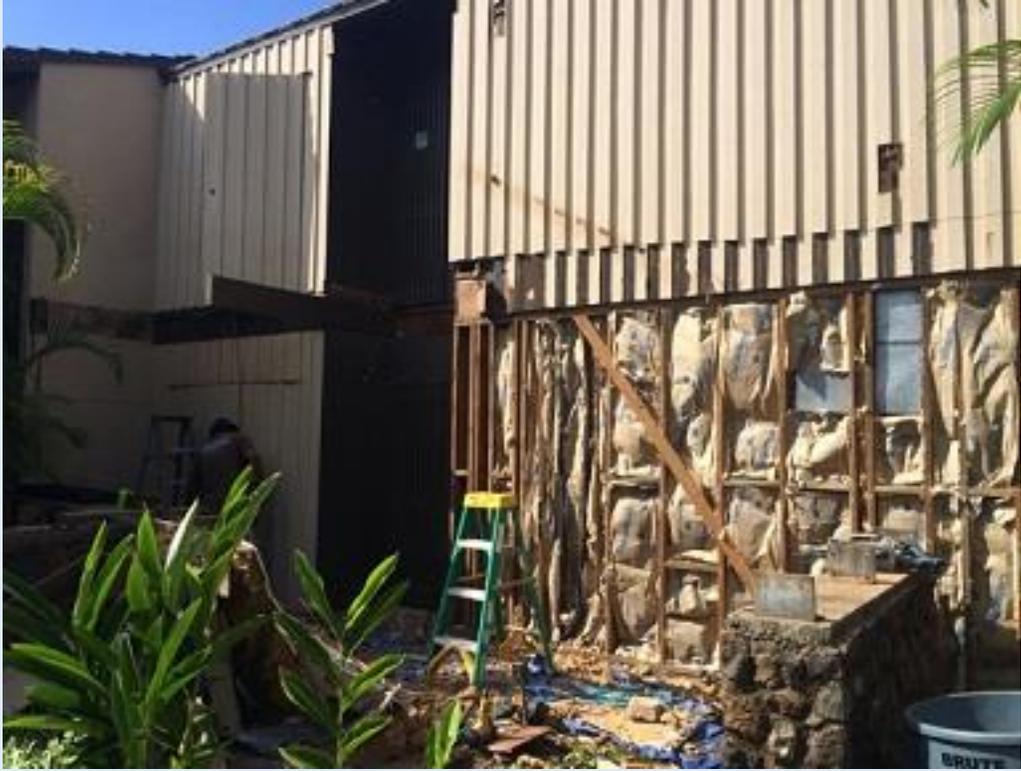
The following photo is from Building 2. This is Phase 1 work being done by our contractor's crew. The stair frame was rotten and some wood near the entry to 204 was rotted into the wall. The stairs were completely disassembled. All rotten wood discarded. The wood cladding on the walls was taken off, insulation added where there was none. Then the walls were covered with a textured plywood and painted to match the existing walls. When Phase 2 begins next year, these walls will be covered in stucco. The plywood installed during Phase 1 serves as the base for the stucco. Installing stucco will go quickly due to the preparation done this year.
